Inspection Report
Minerals Regulatory Program
Date: 07/01/2009

| Mine Name: Rim/Columbus | Permit Number: M0370006 |
| Operator Name: Denison Mines (USA) | Inspection Date: 04/07/2009 |

M0370006 - Rim Columbus
Photos taken April 7, 2009

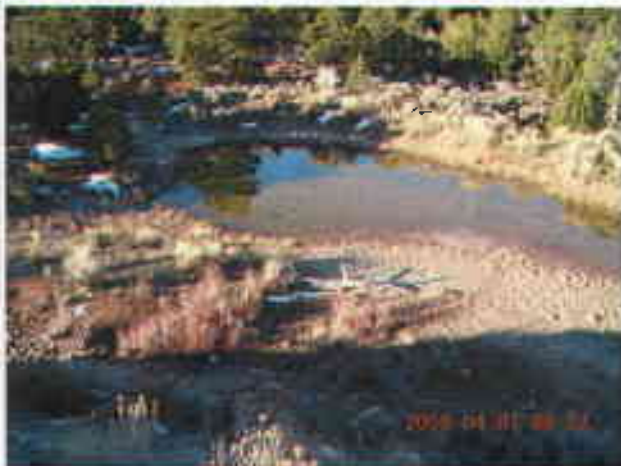
Sediment pond west of the pad and waste rock site

An investigation should be carried out to determine the impacts associated with the animals having access to the sediment pond water. Perhaps a different sediment control scenario should be devised to prevent access to the current sediment pond if it is a watering hole for animals.

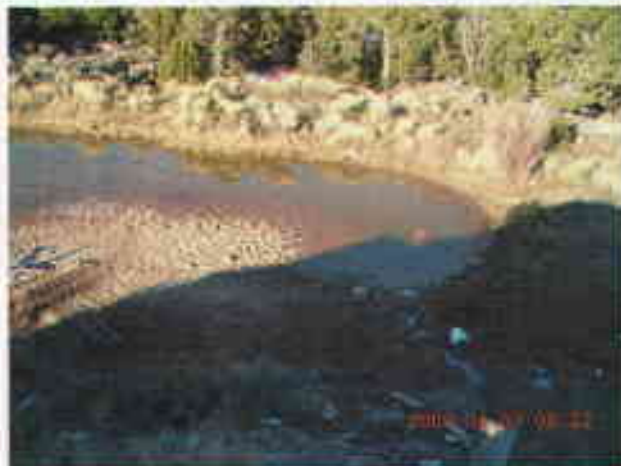
Inlet to sediment pond

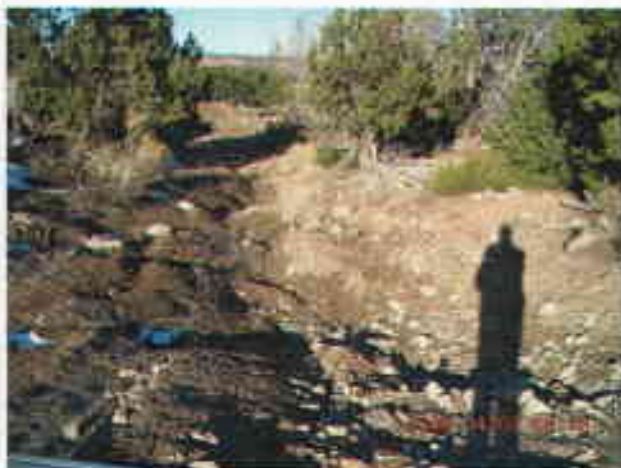
Sediment ditch leaving the pad

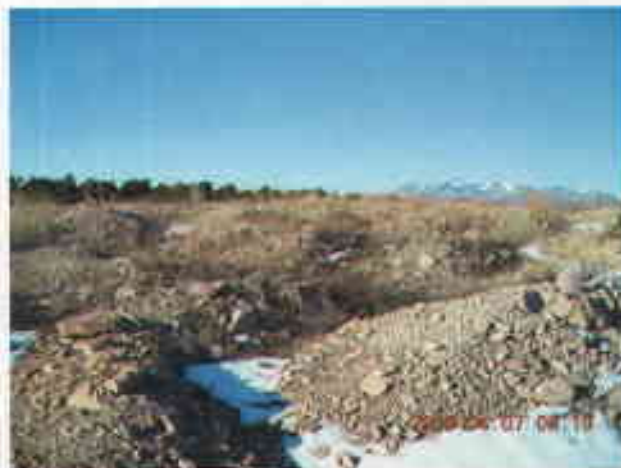
Roughened waste rock where reclamation has taken place with poor revegetation
